## THE MORPHOLOGICAL IMPACT OF THE COLIBIȚA HYDROTECHNICAL SYSTEM ON THE BISTRITA ARDELEANA RIVERBED

**ABSTRACT.** Large dams, as well as conventional hydrotechnical constructions with the role of breaking the drainage slope (waterfalls or bottom sills), flood mitigation or with the role of protection against floods (shore defences) have a profound impact on the environment. Due to these constructions, the ecosystems on the Bistrița Ardeleană river have undergone changes or even established new ones. This paper wants to highlight the morphological changes of the Bistrița riverbed by analysing the transversal profiles made between 1972 and 2015. The profiles were made in the flow measurement section at two hydrometric stations, one being located in the upstream part of the river basin and the other before the Bistrița river flows into the Șieu river. By comparing the results obtained from the profiles made before the Colibița hydrotechnical system was started or completed with the data obtained from the profiles after the commissioning of the Colibița hydropower plant, we managed to highlight that the Bistrița Ardeleană riverbed registered several negative effects in terms of morph

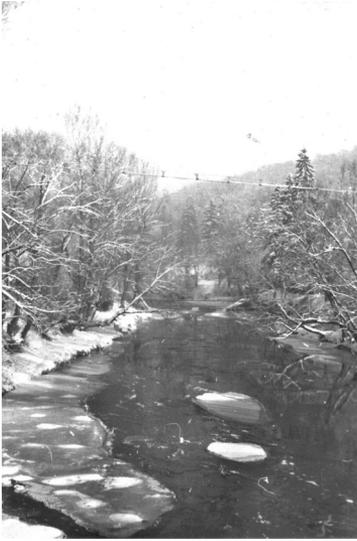
**Fig. 3. Bistrița riverbed upstream of Bistrița hydrometric station in 1968 (\*)**

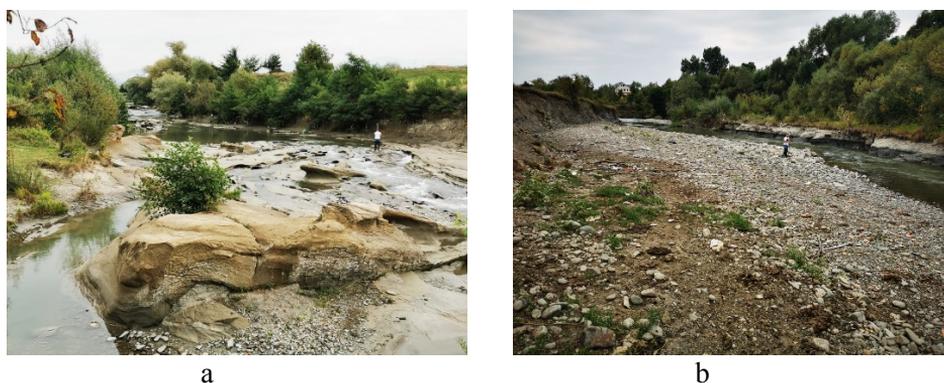
**Fig. 5. Critical sector in a) Livezile and b) Unirea locality's in 2020**

In the localities, upstream of the municipality of Bistrița, significant bank and thalweg erosion were created. Through the erosion process of the riverbed, the alluvial material was removed to the marl layer.
